Case Reports

Inappropriate Implantable Cardioverter-Defibrillator Shocks

Attributed to Alternating-Current Leak in a Swimming Pool

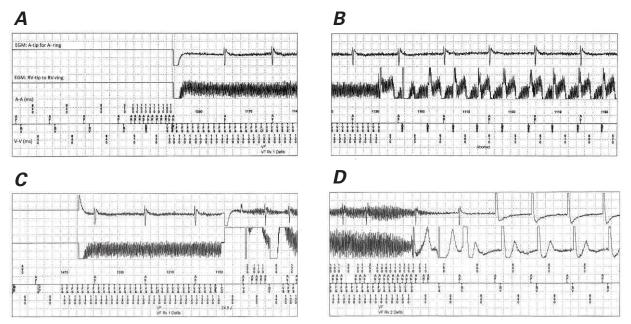
Interrogation of the ICD revealed 2 shocks for electrical activity that the device had interpreted as ventricular fibrillation (Fig. 1). The remainder of the interrogation report revealed normal function, sensing, and evaluation of thresholds by iterative output testing; 3 unrelated episodes of paroxysmal atrial fibrillation had not evoked therapy. The discharges corresponded with the times when the patient was in the swimming pool.

Fig. 1 A) Initial portion of electrogram strip shows substantial noise and electromagnetic interference. The interference corresponds to the time when the patient was in the swimming pool. B) Continuation of electrogram shows noise, interpreted by the device as an intrinsic ventricular signal. C) Continuation of electrogram shows electromagnetic interference, interpreted as ventricular fibrillation and evoking 2 shocks. D) Electrogram shows the termination of electromagnetic interference and resumption of biventricular pacing, most likely corresponding to when the patient was pulled from the swimming pool.

Although increased ICD sensitivity can protect patients who are predisposed to malignant ventricular dysrhythmias, it comes at the price of potentially oversensing environmental stimuli. Electricity is delivered by means of alternating current, usually at a frequency of 50 to 60 Hz. In our patient, the alternating current was misinterpreted as ventricular fibrillation at an average cycle length of approximately 130 ms. The use of true bipolar sensing can minimize much detection of EMI, but at the cost of a narrower detection vector. Also potentially helpful is the use of an auto-adjusting algorithm, as well as auto-gain.¹² Further discoveries in this area might minimize day-to-day activity restrictions in patients with implanted devices.

Despite all the improvements in device performance, lead technology, and programming that were not foreseeable even 10 years ago, inappropriate discharge remains a challenge that can lead to morbidity and death. We think that more research and development should focus on updating devices so that they filter common EMI sources and still detect myocardial signals associated with dysrhythmias. Meanwhile, clinicians should advise patients to avoid potential hazards, including swimming pools that might contain leaking alternating current. In addition, pool manufacturers should be advised of this risk to ICD and PPM patients and be urged to minimize electrical leaks.
