Aortic Perforation by Active-Fixation Atrial Pacing Lead:

An Unusual but Serious Complication

Perforation of a cardiac chamber is an infrequent but serious sequela of pacemaker lead implantation. An even rarer event is the perforation of the aorta by a protruding right atrial wire. We present here the first case in the medical literature of aortic perforation as a sequela to the implantation of a cardiac resynchronization therapy defibrillator.

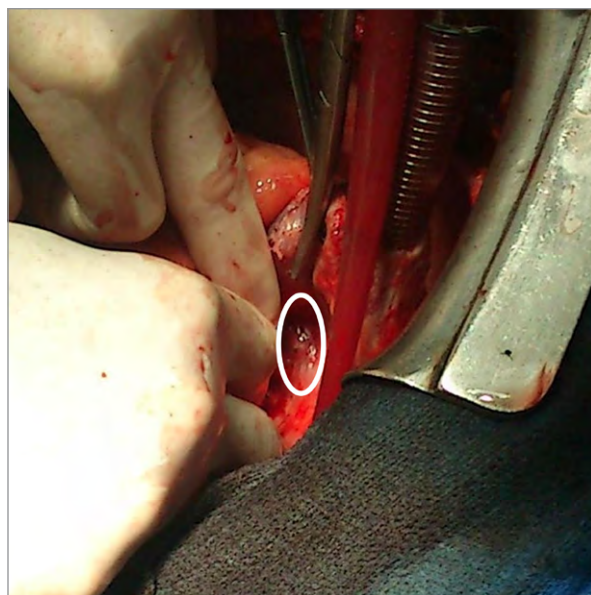
Fig. 1 Intraoperative photograph shows the small puncture of the atrial wall caused by the helix of the atrial active-fixation lead (within the circle). Right atrial cannulation for extracorporeal circulation is also shown.

was caused by mechanical friction from the atrial lead. We also observed a small erosion of the atrial wall, without active bleeding from the right atrium, and we could palpate the helix of the right atrial lead that protruded from the right atrium (Fig. 1). Thorough inspection of the pericardium and the 2 ventricular leads revealed no other bleeding sites. After extracorporeal circulation was established, both the aortic and atrial punctures were repaired with Prolene sutures reinforced by Teflon pledgets (Fig. 2). Together with suturing the atrial puncture, we plicated the atrial wall above the atrial lead in order to cover the tip of the lead and prevent further damage to the atrial or aortic wall. There was no need to reposition the atrial lead, because it functioned correctly.

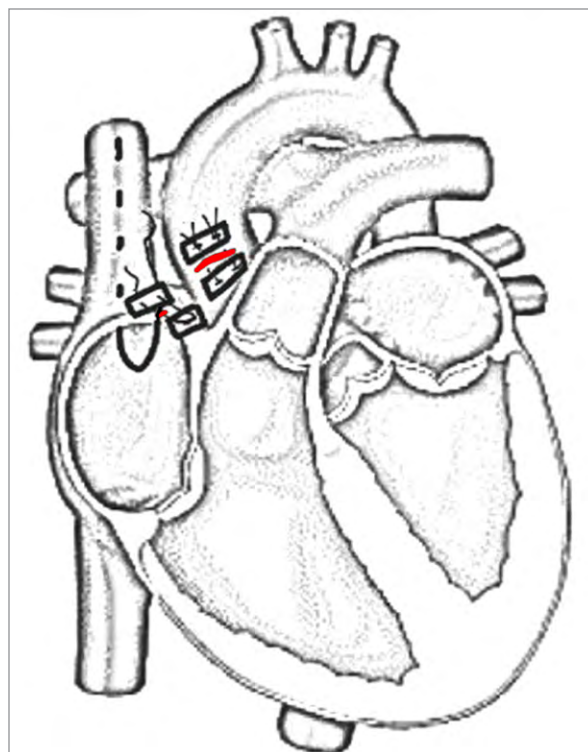
Fig. 2 Anatomic sketch shows the close relationship between the atrial lead and the aorta. Note also the lesions (red) of the atrial and aortic walls and the Prolene sutures reinforced by Teflon pledgets, which were used to repair both wounds.

Six hours later, the patient reported the sudden onset of chest pain and profound dizziness. He was found to be pale, diaphoretic, and severely hypotensive (systolic blood pressure, 60 mmHg). An urgent echocardiogram showed severe pericardial effusion with signs of cardiac tamponade. Because of his hemodynamic instability, the patient underwent immediate sternotomy and a severe hemopericardium was drained. Inspection of the mediastinal space showed that the outflow of bright red blood arose from a very small perforation of the aortic root, in the region of the noncoronary sinus of Valsalva—just in front of a protruding right atrial pacemaker wire. This aortic ulcer

Aortic perforation by a pacemaker lead is a very rare and life-threatening event. In the reports published up to the present time, its clinical presentation always took the form of cardiac tamponade. Immediate surgery is mandatory to diagnose and treat this severe sequela. In our patient, aortic perforation was undoubtedly due to the pacing lead's puncturing the right atrial wall and injuring the adjacent ascending aorta by mechanical friction. Moreover, this result was probably abetted by the severe dilation of the right atrium and by the increased right atrial pressure associated with the patient's advanced stage of heart failure.
