# Fractured Inferior Vena Cava Filter Strut

Presenting with ST-Segment  
Elevation and Cardiac Tamponade

*The fracture of an inferior vena cava filter strut and its migration to the heart is a rare sequela of implanted inferior vena cava filters. Perforation through the right ventricle into the pericardium with resultant cardiopulmonary compromise is even less frequent. We report the case of a 53-year-old man who presented with chest pain and hypotension consequent to cardiac tamponade. A fractured inferior vena cava filter strut had migrated and perforated his right ventricle. The fractured strut was successfully removed by means of cardiac surgery. Inferior vena cava filters should be placed when necessary to minimize the risk of pulmonary embolism, and regular radiologic monitoring should be performed; however, the eventual extraction of retrievable filters should be considered. In addition to discussing the patient's case, we briefly review the relevant medical literature. (Tex Heart Inst J 2015;42(2):181-3)*

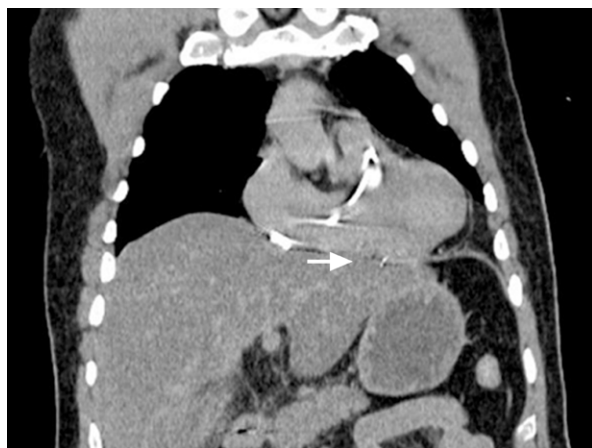
**Fig. 2** Longitudinal section of a computed tomogram of the chest and abdomen shows a fractured inferior vena cava filter strut (arrow) at the inferior border of the heart.

The patient was taken to the operating room and underwent pericardial fenestration, with drainage of 450 mL of blood. His blood pressure improved after the procedure. A computed tomogram (CT) of the chest and abdomen revealed a slightly curved foreign body. It was partially in the RV and had traversed the anterior RV wall into the pericardium (Figs. 1 and 2). An abdominal CT showed an IVC filter with a missing anterior strut (Fig. 3). The patient underwent surgical extraction of the IVC filter strut, which had perforated the diaphragmatic surface of the RV. He had an uneventful recovery and was discharged from the hospital after 5 days.

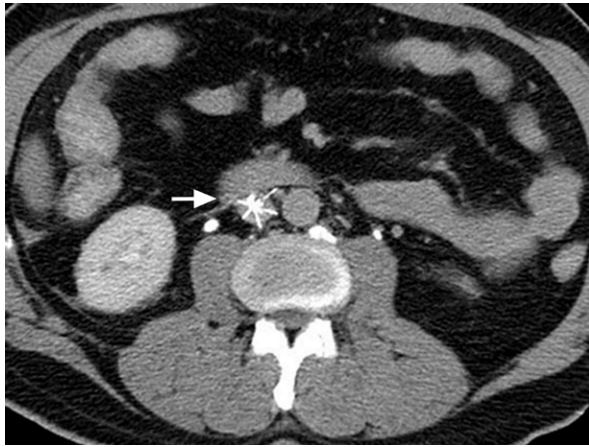
**Fig. 3** Computed tomogram of the abdomen shows the missing filter strut anteriorly (arrow).
