Evaluation of Suspected Device Malfunction on ECG

Luke Cunningham, MD
Henry D. Huang, MD
Yochai Birnbaum, MD

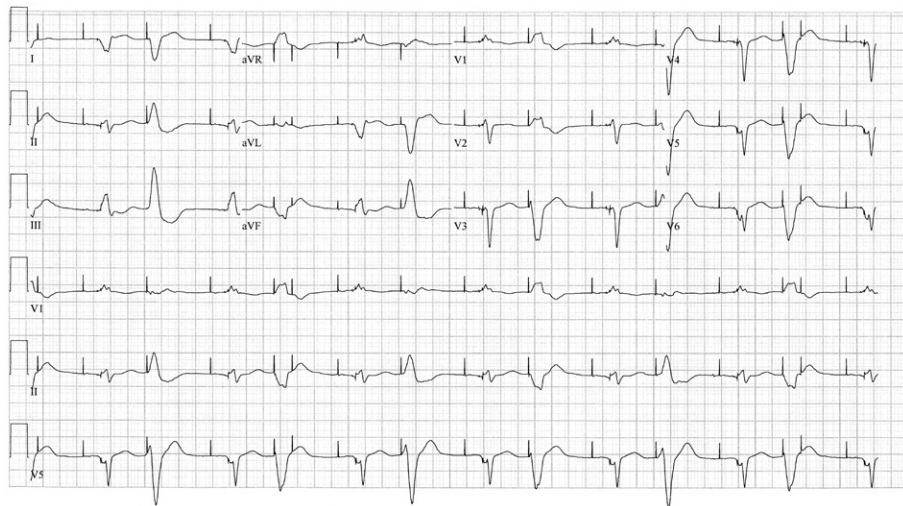
Fig. 1

A 62-year-old man with nonischemic cardiomyopathy, a history of Boston Scientific biventricular implantable cardioverter-defibrillator placement (in 2011), ventricular tachycardia after radiofrequency ablation (April and November 2014), paroxysmal atrial fibrillation, and severe mitral regurgitation presented with acute exacerbation of heart failure. A resting electrocardiogram (ECG) showed normal sequential atrioventricular (AV) pacing at a heart rate of 63 beats/min. Baseline device settings were DDD with a lower rate of 60 beats/min, an upper rate of 115 beats/min, a minimum sensed AV delay of 135 ms, and a minimum paced AV delay of 180 ms. The patient underwent mitral valve replacement. Three days later, the pacemaker rate was increased to 80 beats/min, and an ECG showed paced pacing concomitantly within the T wave in beats 5 and 13 of the rhythm strip (Fig. 1).

The ECG is compatible with normal function of the device. Biventricular pacemakers frequently have features that attempt to promote pacing and thus ventricular resynchronization. Ventricular sense response resynchronizes ventricular depolarization upon frequent changes in R-R intervals, particularly in patients with atrial fibrillation or frequent premature ventricular contractions (PVCs). On a surface ECG, these events appear as pacing stimuli within a native ventricular depolarization during the attempt to resynchronize the ventricle. This can lead to fusion or pseudofusion beats, depending on the effect of pacing on the depolarization. Typically, these resynchronization stimuli occur 1.25 ms after the initial ventricular stimulus and would not be expected during the T wave.¹

In this ECG, the AV delay is near the programmed minimum at 200 ms in sequentially paced beats (as shown on beat 2). On beat 3, an atrial stimulus and a PVC appear to inhibit further pacemaker output. On beat 5, an atrial stimulus and PVC appear almost simultaneously. A pacemaker stimulus follows, notably after a 200-ms delay. This suggests that the PVC occurred during the device's ventricular blanking period, during which the ventricular lead is "blinded" to native ventricular depolarization and thus continues programmed pacing. Therefore, an appropriate 2nd stimulus attempts to pace the ventricle. Pacing stimuli on a T wave can theoretically produce ventricular tachycardia or fibrillation and should prompt device evaluation.^{2,3}

In many devices, when a PVC occurs immediately after the post-atrial ventricular blanking (PAVB) period, the PVC usually falls within the crosstalk zone and leads to ventricular-safety pacing. This sequence is initiated after an atrial-paced stimulus, after which comes a sensed event in the ventricular channel. The AV delay of the safety-paced beat is usually much shorter than the programmed AV delay. However, on beat 2 of our patient's ECG, the expected safety pacing was absent, because this manufacturer's pacing algorithm does not use a crosstalk zone for safety pacing. There is only a programmable PAVB period, selected manually (range, 30–200 ms).

Of note, PVCs occurred in a similar manner in our patient, after which a 2nd pacemaker stimulus did not occur on the T wave. Upon review of the timing and morphology of each PVC, ECG beats 3, 7, and 11 had a similar morphology: negative deflection in lead aVL, positive deflection in leads II through aVF, and an early R wave in lead V₁. This suggests a left lateral location—spatially the farthest from the RV lead, allowing delayed

arrival outside the blanking period of the RV lead and thus inhibiting stimuli output. The remaining PVCs, in contrast, appear to have had a positive deflection in lead aVL and a negative deflection in leads II through aVF, suggesting an inferoapical left ventricular location much closer to the RV lead. Earlier transit might have caused the inferoapical PVCs to fall within the device's blanking period and led to the discharge seen on the T wave. The exception is beat 9, on which the PVC appears to have occurred about 40 ms later (after the atrial stimuli) than on beats 5 and 13—allowing the signal to fall outside the blanking period and leading to inhibited ventricular-stimulus output.

In this patient, device interrogation showed normal function, no undersensing episodes, and stable lead impedances. No atrial fibrillation or high ventricular rates were recorded. Postoperatively, amiodarone was started, and no further pacemaker stimuli were seen within the T wave.
