Intra-Aortic Migration of a Clipped Epicardial Pacing Wire

Omar Ray Kahaly, MD
Dilesh Patel, MD
Ralph S. Augostini, MD,
FACC
Gregory D. Rushing, MD
Mahmoud M. Houmsse,
MD

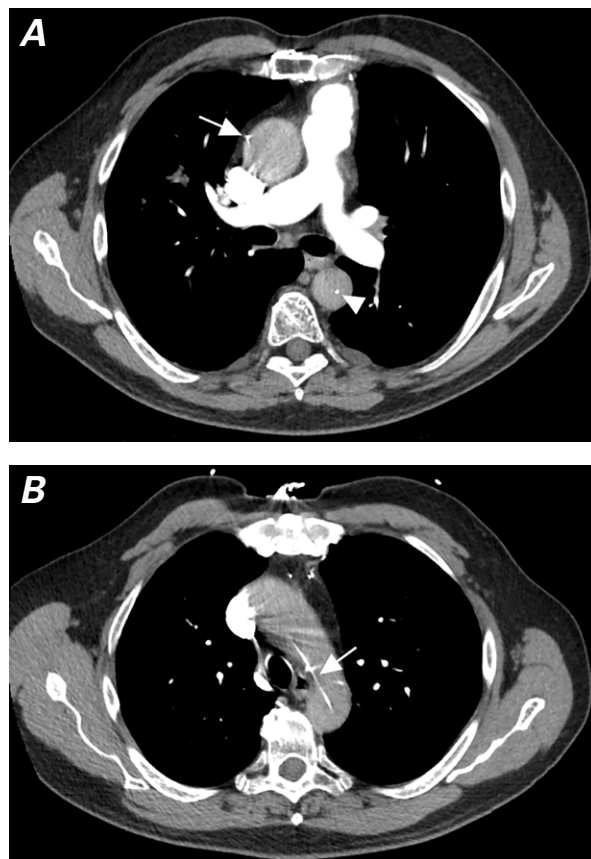
Fig. 1 Chest computed tomograms (axial mediastinal views) show **A**) the temporary epicardial pacing wire entering the ascending aorta above the right atrium (arrow) and the other end in the lumen of the descending aorta (arrowhead), as well as **B**) in the aortic arch (arrow).

A 76-year-old man presented for electrophysiologic evaluation of a temporary pacemaker wire detected in his aorta. His medical history included coronary artery disease, 2-vessel coronary artery bypass grafting (CABG) 16 years previously, congestive heart failure (left ventricular ejection fraction, 0.35–0.40), hyperlipidemia, hypertension, frequent premature ventricular contractions, and single-chamber implantable cardioverter-defibrillator placement. His primary care physician had ordered chest computed tomograms to evaluate shortness of breath, chest pain, and hemoptysis. The images revealed mild infiltrative disease in the right upper lung lobe and a temporary pacemaker wire in the aortic arch. The proximal end of the wire terminated in the right ventricular wall, and the distal end was floating in the descending aorta (Fig. 1). Transesophageal echocardiograms (TEE) showed the wire in the lumen of the descending aorta (Fig. 2).

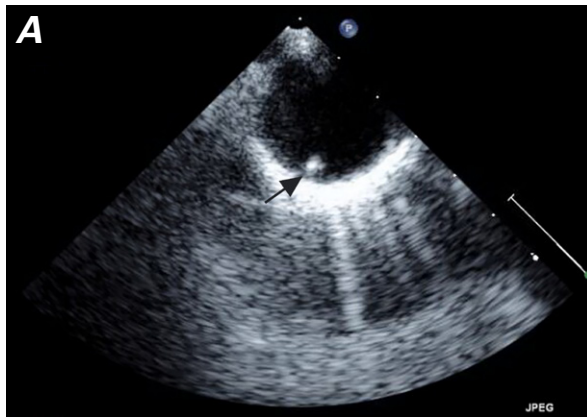
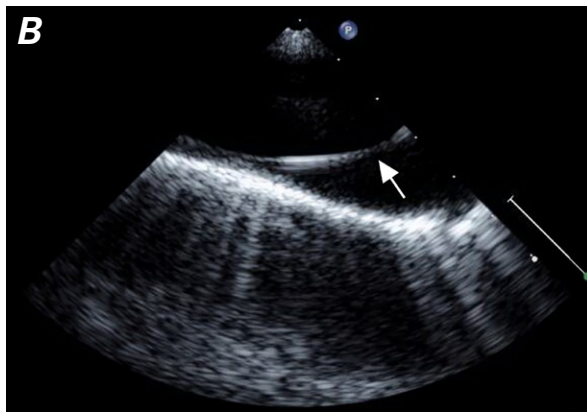
Fig. 2 Transesophageal echocardiograms at **A)** 0° and **B)** 99° show the temporary epicardial pacing wire (arrows) in the lumen of the descending aorta.
