# Use of a Sandwich Technique

## to Repair a Left Ventricular Rupture after Mitral Valve Replacement

Myles E. Lee, MD  
Mallika Tamboli  
Anthony W. Lee, MD

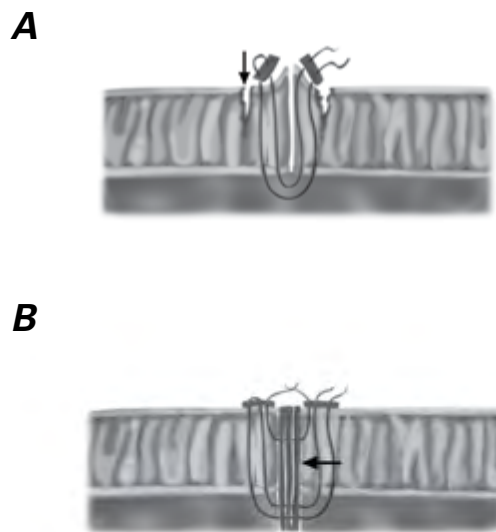
**Fig. 1** Graphic shows **A**) collateral myocardial tears (arrow) with use of pledgeted mattress sutures, and **B**) insertion of a felt plug (arrow) in the “sandwich” technique. (Monica Edwards, artist)

repair with 3-0 and 4-0 Prolene pledgeted mattress sutures were unsuccessful because of collateral tears in friable tissue adjacent to the defect. Finally, we cut pieces of 2-mm-thick polytetrafluoroethylene felt (Bard Peripheral Vascular, Inc.; Tempe, Ariz) to produce a plug that approximated the size of the defect. We placed the plug into the defect and sandwiched it in place with pledgeted 0 ETHIBOND® mattress sutures (Ethicon, Inc., a Johnson & Johnson company; Somerville, NJ) on an aneurysm needle. We then passed figure-of-8 sutures of 2-0 Prolene through the pledgets of the ETHIBOND sutures and through the plug, to prevent its migration into the ventricular cavity (Fig. 1). We applied a fibrin-based sealant to the repair site and terminated CPB, with complete hemostasis.

Our external repair involved the use of deep pledgeted horizontal mattress sutures that passed through—and held in place—pieces of Teflon placed within the defect. Additional figure-of-8 sutures were passed more superficially through the plug, to prevent its migration into the LV cavity. The Teflon served as a space-filling buttress that reduced the distance needed to approximate the edges of the rupture; this in turn reduced the tension on the pledgeted sutures needed to achieve hemostasis. This simple technique helped to avoid further collateral tearing of the adjacent myocardium. We think that reduction of the tension on the securing sutures was the key element in our successful repair of the rupture.
