Use of Computed Tomography to Distinguish Thrombus from Pannus

on a Bioprosthetic Aortic Valve

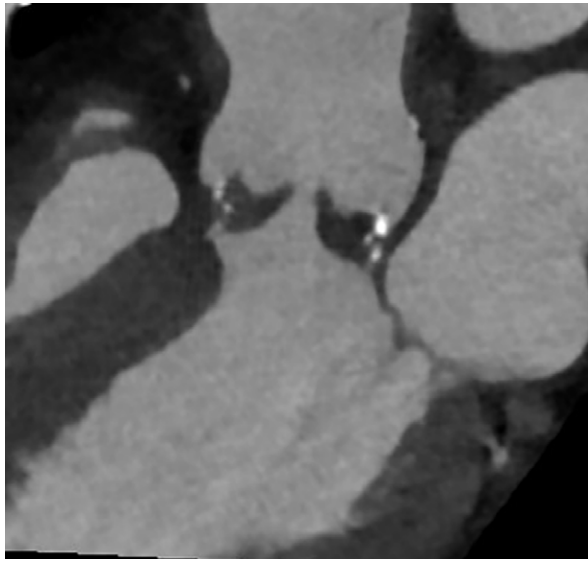
Fig. 1 Cardiac computed tomogram (reconstructed 3-chamber view with multiplanar reformatting) shows circumferential hypoattenuated leaflet thickening of the bioprosthetic aortic valve.

In January 2015, a 75-year-old man with severe aortic stenosis underwent SAVR with use of a 27-mm Epic[™] valve (St. Jude Medical, an Abbott company). Postoperatively, complete heart block led to dual-chamber pacemaker implantation. Two years later, a transthoracic echocardiogram (TTE) was obtained to reevaluate left ventricular systolic function under 100% right ventricular pacing. The TTE showed a substantially elevated transvalvular aortic gradient (mean gradient, 49 mmHg; peak velocity, 4.4 m/s), along with reduced leaflet motion (effective orifice area, 0.7 cm²), suggesting severe prosthetic valve stenosis. It was unclear whether the valvular dysfunction resulted from pannus or thrombus formation. Contrast-enhanced cardiac CT (with retrospective electrocardiographic gating, no dose modulation, 120 kV) was subsequently performed with use of a second-generation, dual-source, 128-slice SOMATOM[®] Definition Flash scanner (Siemens Healthcare). The images revealed circumferential hypoattenuated material originating from the junction of the prosthetic valve ring and leaflets, resulting in severe leaflet thickening (Fig. 1) and reduced leaflet motion (Fig. 2), which are consistent with BPVT. Oral warfarin therapy was initiated. Three months later, TTE showed normal Doppler echocardiographic values (mean gradient, 6 mmHg; peak velocity, 1.8 m/s) and leaflet motion (effective orifice area, 1.6 cm²). Cardiac CT showed dramatic resolution of the hypoattenuated thrombotic material, as well as normal leaflet thickness and mobility (Fig. 3). The patient remained
