Aortic Root Dissection Due to an Automated Fastener Device

Minimally invasive aortic valve replacement through a right thoracotomy is frequently performed in patients with aortic valve disease. The Cor-Knot Device (LSI Solutions) is an automated fastener that secures valve sutures.

This case report is for a patient who developed postcardiotomy shock during a minimally invasive aortic valve surgery. The patient was found to have an aortic root dissection involving 90% of the aortic root circumference, including bilateral coronary ostia. The autopsy revealed that the aortic damage could be explained by a direct aortic intimal tear from the distal tip of the device shaft. The device was most likely not in perfect apposition to the sewing ring because of the restricted angle and space between the ribs. (Tex Heart Inst J. 2022;49(6):e207531)

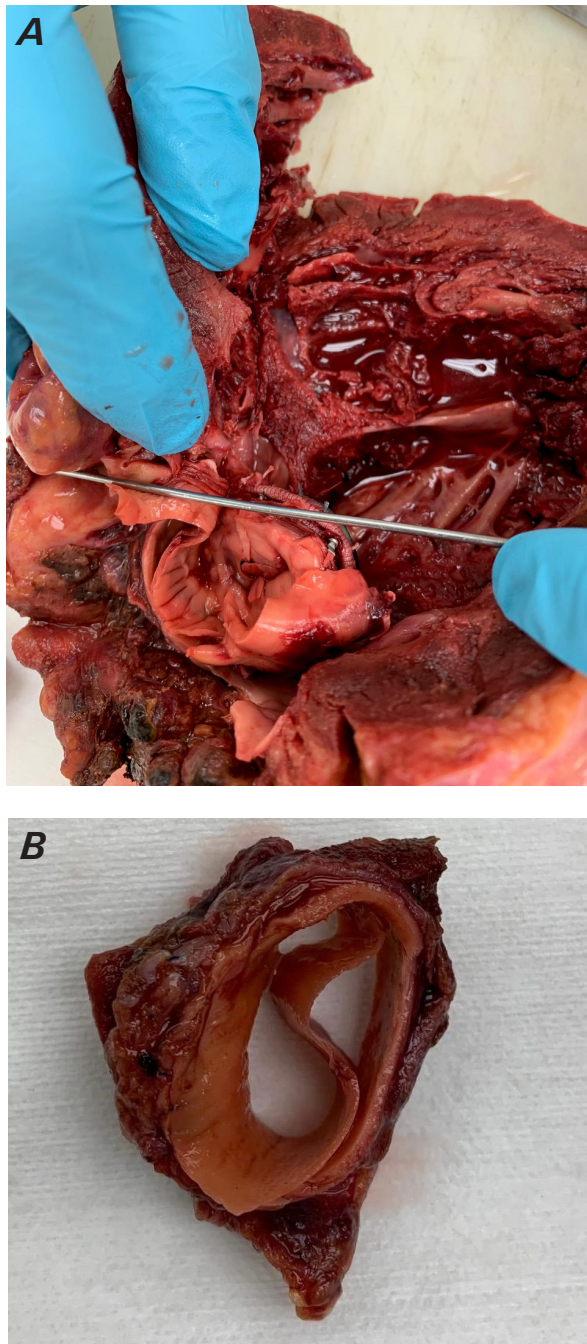
valve was in place with Cor-Knot sutures (Fig. 1). An organizing thrombus entirely occluded the mechanical valve on the aortic side. An aortic root intimal dissection with organizing circumferential aortic thrombus was also present (Fig. 1A and Fig. 1B). Histological examination showed that the dissection involved a separa-

Fig. 1 A) Opened left ventricle showing the mechanical prosthetic valve attached with Cor-Knot sutures to the aortic annulus. The dissection flap is in the posterior aorta. The probe points to the occluded left main coronary artery. A thrombus on the surface of the prosthesis has been removed, but the clot in the ventricle is seen. **B)** The aortic root, showing dissection flap.

Acute aortic dissection is an infrequent and devastating complication during aortic valve surgery, especially if undetected intraoperatively. In the autopsy, the initial aortic tear appeared directly above the titanium fastener (Fig. 1). This resulted in a dissection lifting the intima from the media (Fig. 2). This damage could be explained by a direct tear from the distal tip of the device shaft, which may not have been in perfect apposition (perpendicular orientation) to the sewing ring owing to the restricted space between the ribs (Fig. 3). It is also possible that the metallic fastener produced repetitive trauma on the aortic wall, causing disruption. However, another mechanism for aortic wall tear damage could be aortic wall manipulation resulting from instrument use during annular measurement, placement of annular sutures, and valve positioning, although these seem to be less likely. Although the dissection was not directly observed in the procedure, the pathology report strongly supports the theory that the device was the cause of the dissection. The pathogenesis of the dissection appears to be related to aortic root trauma secondary to either the distal tip of the shaft from the Cor-Knot device or aortic trauma from the fastener metal clip.

The authors believe the minimally invasive approach may have contributed to the dissection. The manufacturer recommends placing the distal tip of the device shaft on the prosthetic sewing ring, and this apposition must be achieved. However, using the Cor-Knot device via the minimally invasive approach may limit the visualization of the placement of the device's tip, especially during a small right thoracotomy where proper angulation of this device is limited. Awareness among surgeons about the importance of always obtaining complete visualization of the shaft and sewing ring and the perpendicular apposition between them at all times is vital. Automated fasteners improve operative times, but caution during application should be used. If the surgical approach obscures direct visualization, alternative methods are advised.

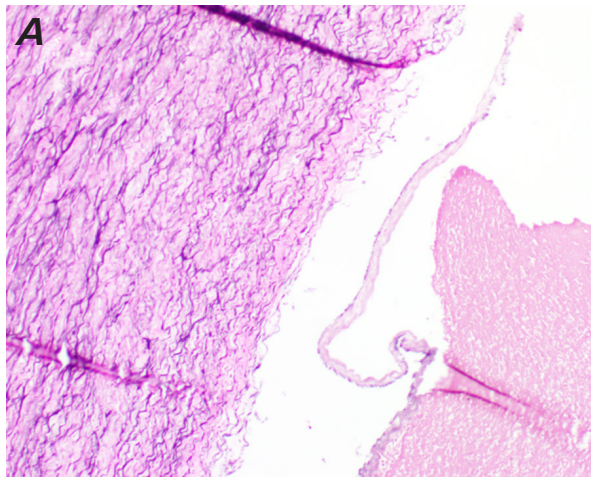
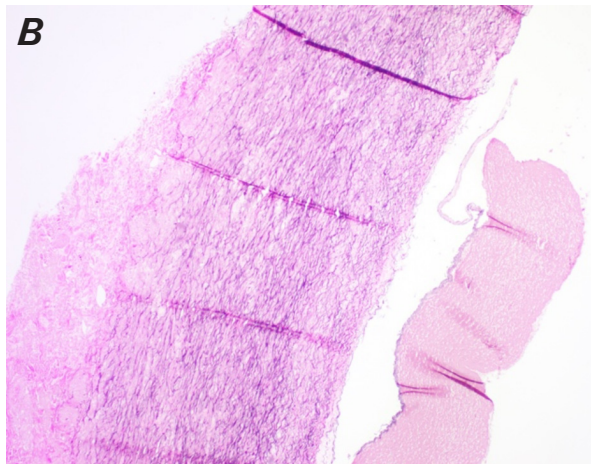
tion of the intima from the media (Fig. 2A and Fig. 2B). However, neither the transthoracic echocardiogram nor the transesophageal echocardiogram showed any aortic flap that suggested dissection. The aortic root dissection involved 90% of the aortic root circumference, affecting the bilateral coronary ostia. Both the left anterior descending and right coronary artery ostia were also occluded by thrombi (Fig. 2C). Massive premortem thrombi filled the left ventricular cavity. Extensive areas of ischemic changes were identified in the bilateral ventricles.

Fig. 2 Histological findings. **A)** The dissection is at a plane between the thin intima and the media; there is a superimposed thrombus (elastic tissue stain, low magnification with $\times 4$ lens). **B)** A closer view of the dissection plane (elastic tissue stain, medium magnification with $\times 10$ lens). **C)** The proximal coronary artery with thrombus (trichrome stain, low magnification with $\times 2$ lens).
