Three-Lobed Donor Left Lungs: Imaging and Clinical Implication in Thoracic Transplantation

Department of Cardiothoracic Surgery, Heart and Lung Transplant programs, Mayo Clinic, Jacksonville, Florida

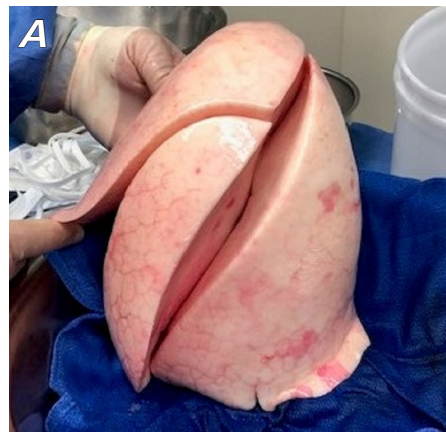
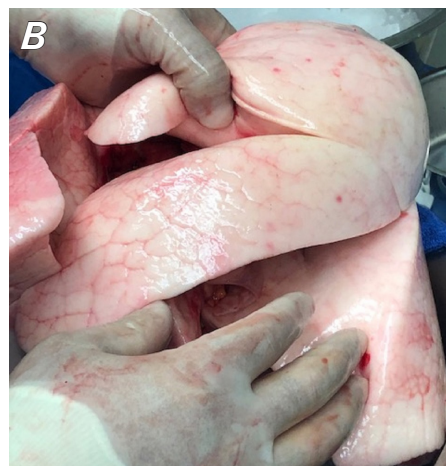
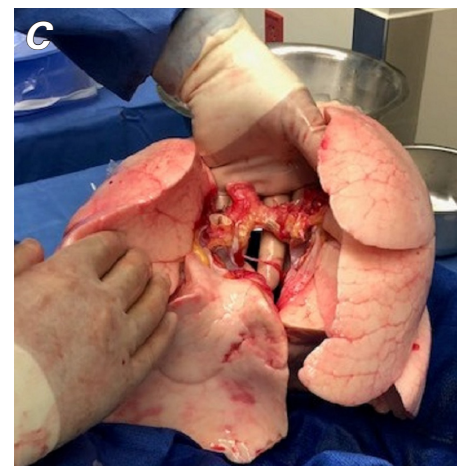
Fig. 1 Trilobed left lung can be appreciated in all the pictures: **A)** lateral view of left lung, **B)** complete separation of the fissure, **C)** view of both lungs.

Nearly 45% to 50% of lungs deviate from standard anatomy described for the fissures, lobes, bronchi, and arteries. Anatomical variations are more common in the right lung (68.7%) than in the left lung (21.4%),¹ and in the left lung, the presence of an accessory horizontal fissure and 3-lobed left lung is very rare and limited to cadaveric studies.² The team recently published a report on the first successful case of a donor-derived trilobed left lung transplant.³ This paper reports the imaging and clinical pictures of a 3-lobed left lung (Fig. 1). The presence of 3 lobes in the left lung could be overlooked on preoperative imaging. However, at the time of procurement and before transplantation, a left trilobed lung should be confirmed by the hilar anatomy and anatomical relationships between the pulmonary arteries, pulmonary vein cuff, and bronchus consistent with the left lung.
